Customer Name:
Acme Insurance

Insured:
The Green Estate

Address to Inspect:
400 First Street, Medusa, NY

12120
ViewSpection #:
135322

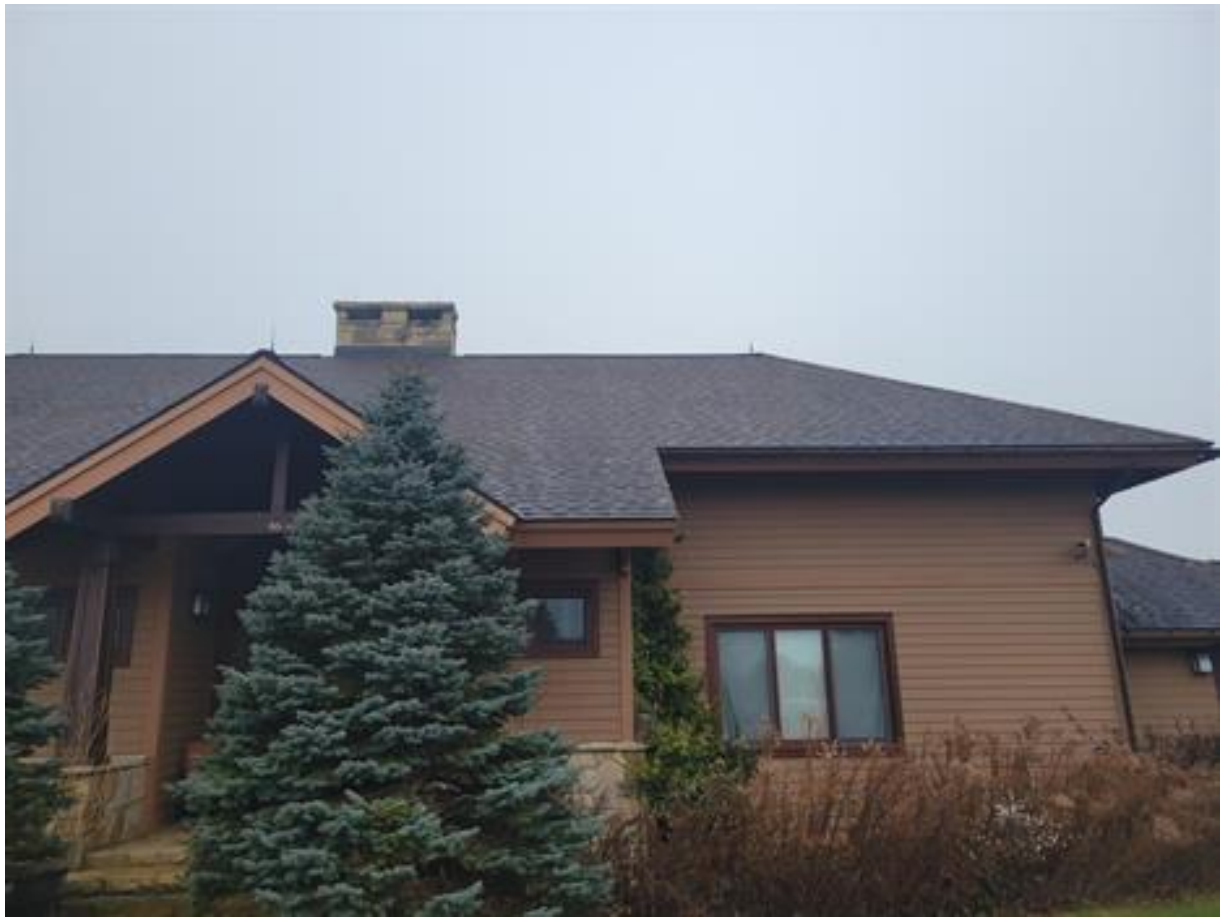
Close Up of Roof

Roof Age (Yrs) as per Insured:	10
Roof was observed?	Yes

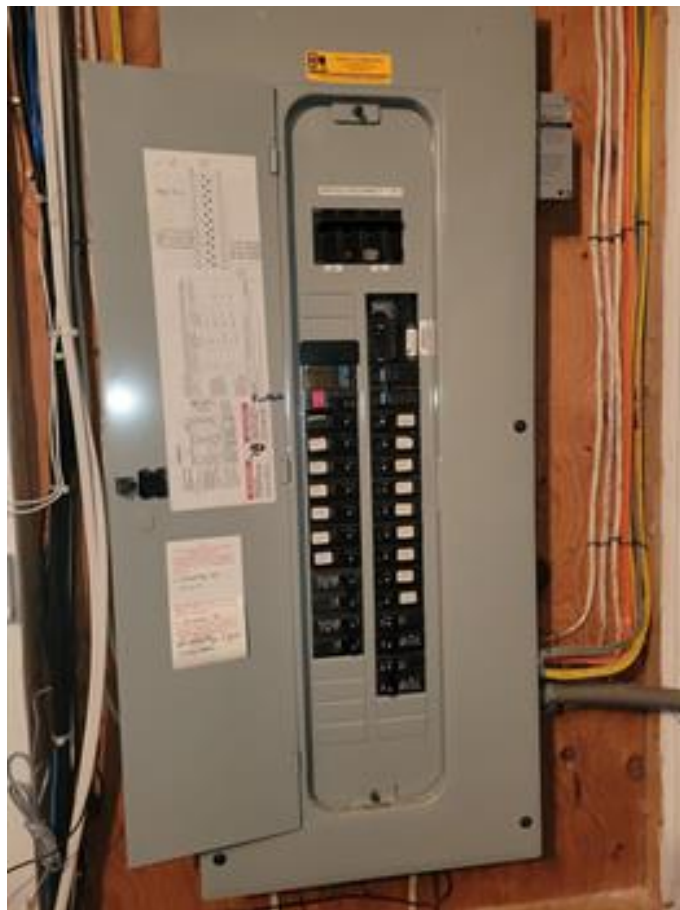
Electric Panel (Door Open)

Type of Electrical	200 amp
Electric Panel Age	23
Panel Type	Breaker
Type of Wiring	Mixed
Wiring age(yrs)	20
Electric	Other
Other Electric Panel Brand	siemens
Murray/Siemans Date Code	na
Square D Date Code	na
Square D QO Date Code	na
The serial number is not readable/present	Yes
Type of Heating System	Oil Boiler
Heating Age	20
Type of AC System	Central Air
AC Age	20
Type of Plumbing	Mixed Copper/Plastic
Plumbing Age	20
Type of Hot Water Tank	Electric
Hot Water Tank Age	20
Age of all Utilities determined by	Insured stated

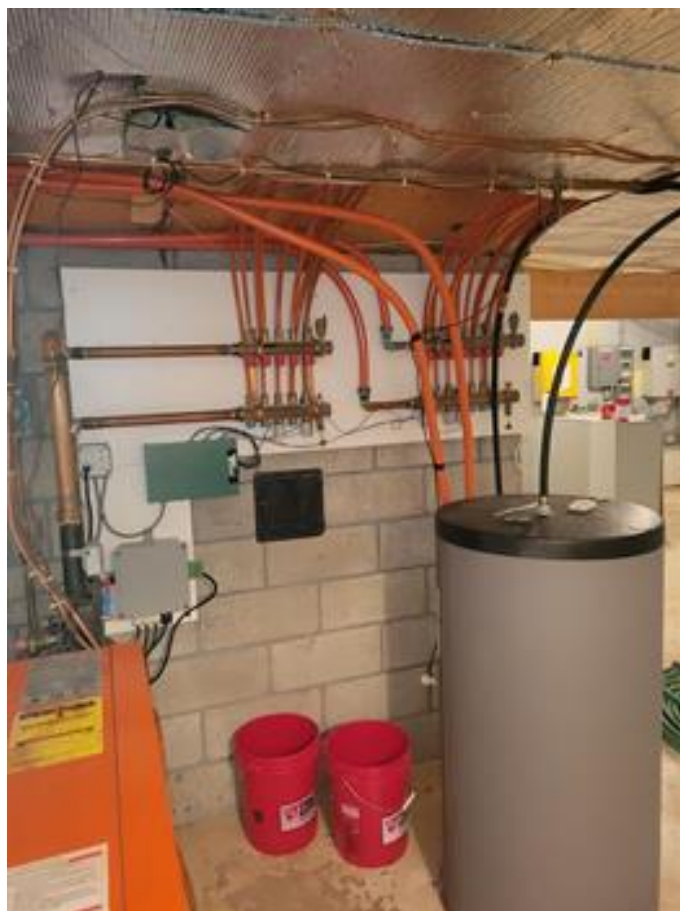
Hot Water Tank

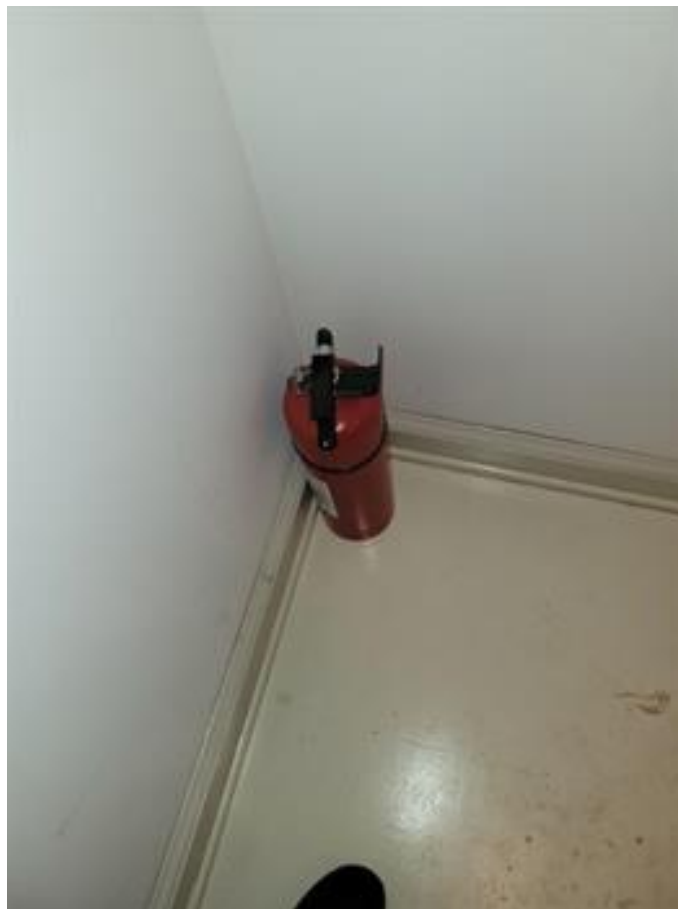
Fire Ext needs annual Service

Fire Extinguisher present	Yes
Fire Extinguisher inspected Annually?	No
Smoke Detector Present	No
Carbon Monoxide detector present	No
Type of Security/Burglar Alarm System	Central Monitored
Type of Fire Alarm system	None

Extinguishers should be serviced on an annual basis by a qualified firm and tagged to show date of service and who performed service (NFPA 10-3-2)
