Customer Name: Policy #: Acme Insurance 4567654

Insured: Address to Inspect:
Max Stanley 1573 Mary Street, NY 14100

Completed By: ViewSpection #: Mark Jensen 111222

Risk is a4500 sf, 2-story, masonry joisted restaurant, tavern built in 1970 with concrete block exterior, rubber membrane roof and a Concrete slab foundation located in Olcott NY. The risk is a corporation with 1 owner. Insured has been at the location for 5 years. The risk is located near the waterfront of Lake Ontario, and in close proximity to a marina. The location's primary season is May to early October. The insured does maintain operations during the winter months. The insured reports currently 2 full time and 4 part time employees. Operating hours vary by season. The location has a inside dining, inside bar, inside banquet and outside dining seating area. Income not reported. Payroll not reported. Considerable snow cover noted in the area, as a major snowstorm had just come through the area. The risk is protected by the Olcott FD located .1 miles away and a fire hydrant located 60 feet away.

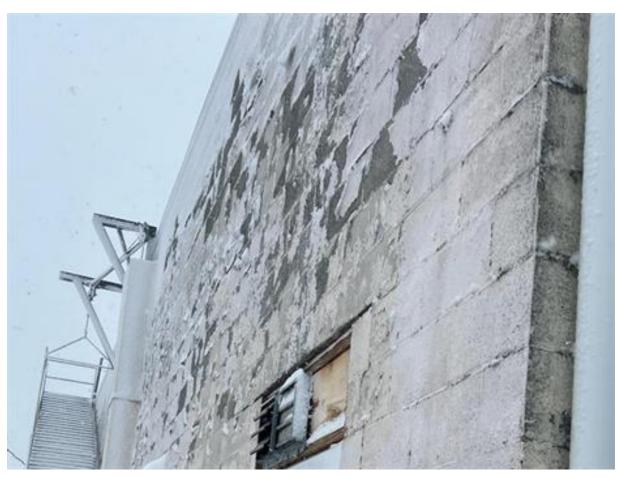
needs paint

needs paint

The siding is in need of priming and painting to improve building condition and reduce the weather damage exposure.

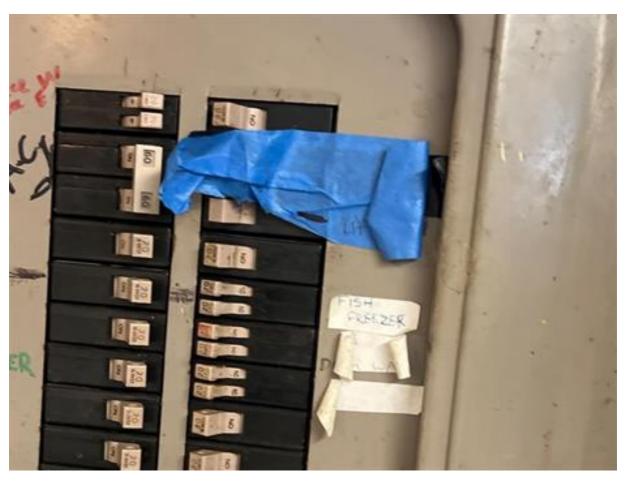
missing breakers

missing breakers

Spaces vacated by missing breakers should be filled with breaker replacements, or with appropriately sized spacer covers to reduce the risk of fire due to arcing or spark.

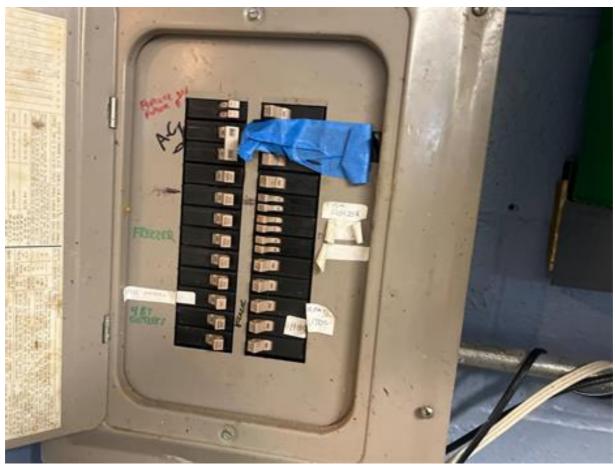
100 amp

Breaker

Electric Panel

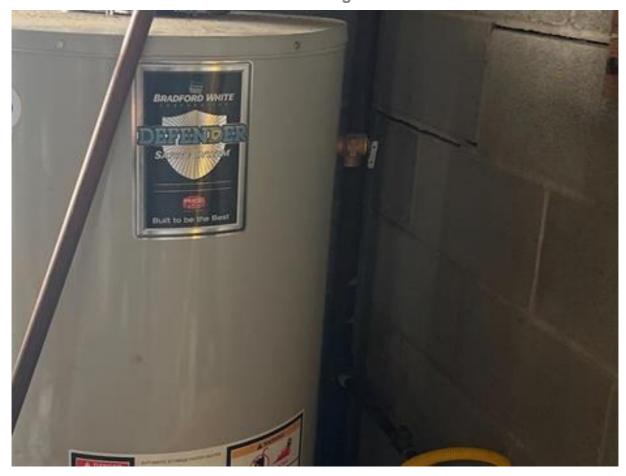
missing down pipe

missing down pipe

The hot water tank was noted to not have a down pipe installed on the pressure relief valve. The down pipe should be installed to reduce the risk of bodily injury due to scalding.

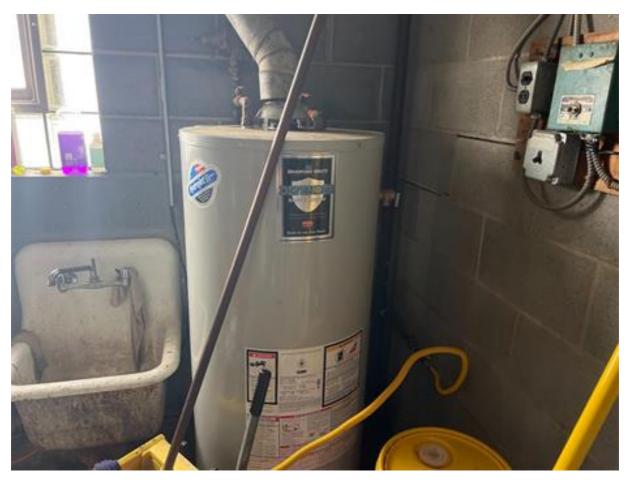
Gas

Hot Water Tank

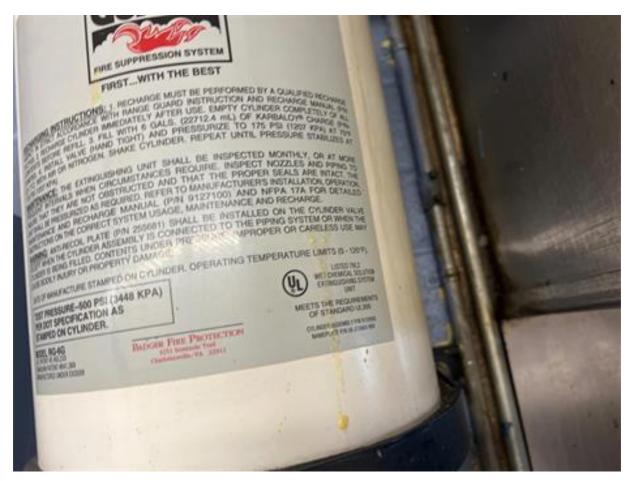
How was UL 300 compliance determined? UL 300 compliance label was seen on system	Nozzles have protective caps in place?Yes No Yes	
	Are there caps on some but not all nozzles?	
Kitchen Fire Extinguishers

UL300 Label

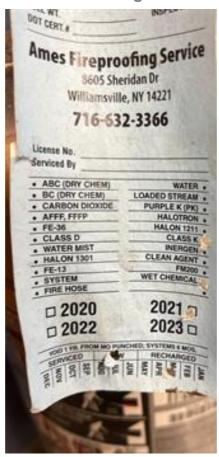
Is K Class extinguisher inspected on an annual basis?

No

Commercial Cooking - The K Class extinguisher in the kitchen

Commercial Cooking - The K Class extinguisher in the kitchen

The K Class extinguisher in the kitchen area should be serviced on an annual basis. This will reduce the fire hazard.

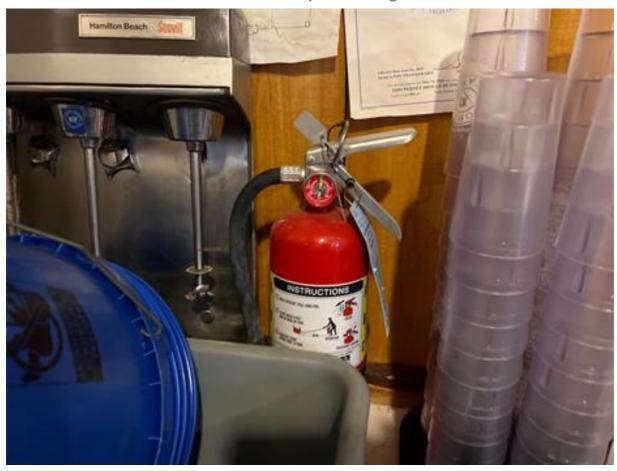
Fire Extinguisher inspected Annually?

No

Fire Extinguisher

Ames Fireproo 8605 She Williamsville 716-63	ridan Ur e, NY 14221	
License No. Serviced By ABC (DRY CHEM) BC (DRY CHEM) CARBON DIOXIDE AFFF, FFFP FE-36 CLASS D WATER MIST HALON 1301 FE-13 SYSTEM FIRE HOSE 2020 2022	WATER • LOADED STREAM • PURPLE K (PK) • HALOTRON • HALOTRON • HALON 1211 • CLASS K • INERGEN • INERGEN • FM200 • WET CHEMICAL • 2021 • 2023 □ WET CHEMICAL •

missing annual inspection of FE

missing annual inspection of FE

Extinguishers should be serviced on an annual basis by a qualified firm and tagged to show date of service and who performed service (NFPA 10-3-2)
