Customer Name:
Acme Insurance

Insured:
The Green Estate

Address to Inspect:
400 First Street, Medusa, NY

12120
ViewSpection #:
135322

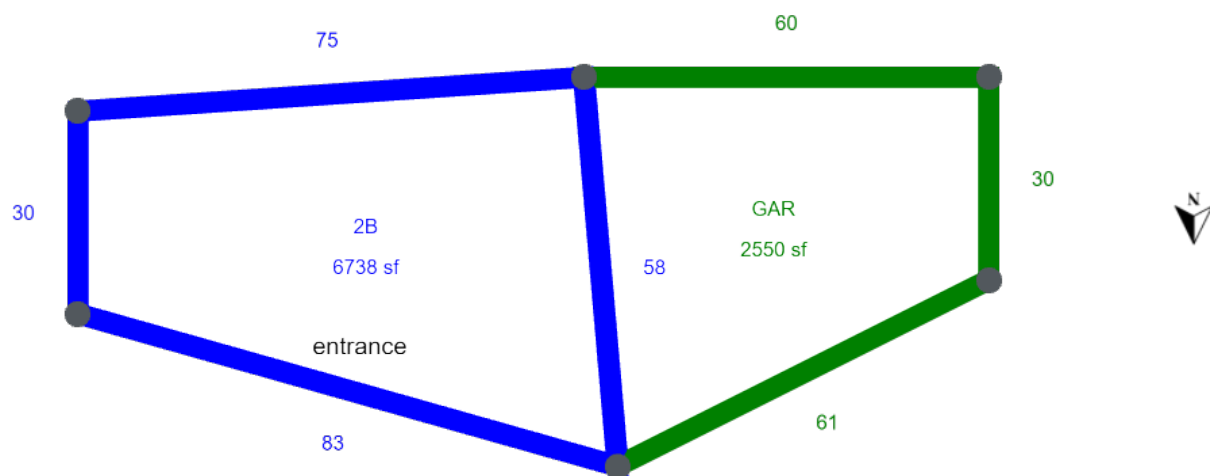
Area Calculations Summary

Code	Name	Factor	Net Size (in Sq.ft)	Net Totals (in Sq.ft)
2B	2B	2	6738	6738
GAR	GAR	1	2550	2550
				Net LIVABLE Area : 6738

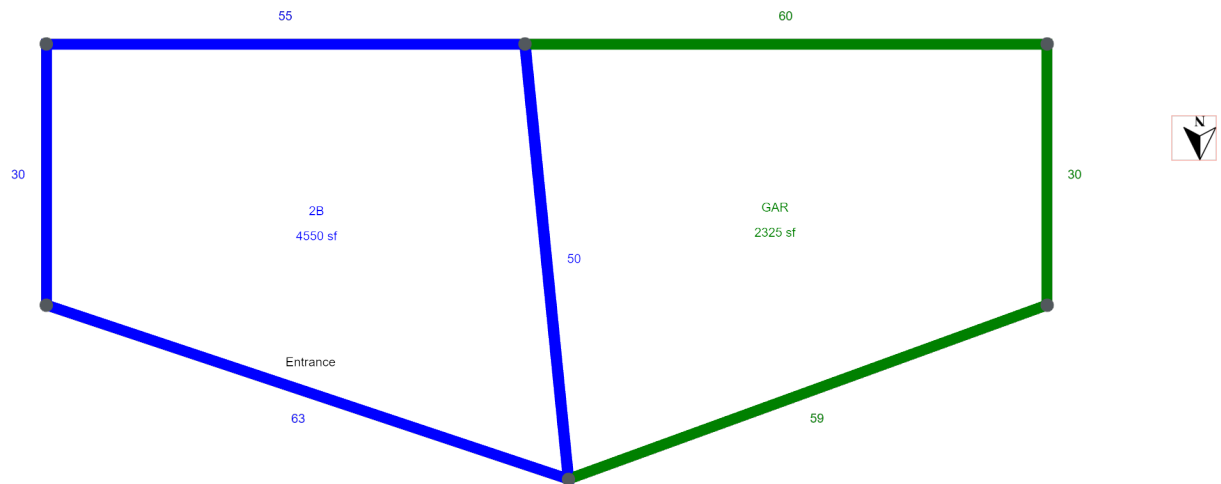
Area Calculations Summary

Code	Name	Factor	Net Size (in Sq.ft)	Net Totals (in Sq.ft)
2B	2B	2	4550	4550
GAR	GAR	1	2325	2325
				Net LIVABLE Area : 4550
